PENNSYLVANIA
CABIN CREEK DAM

NDS ID NO. PA-00336
DER ID NO. 67-459

RED LION MUNICIPAL AUTHORITY
PHASE I INSPECTION REPORT
NATIONAL DAM INSPECTION PROGRAM

NAME OF DAM: Cabin Creek Dam
STATE LOCATED: Pennsylvania
COUNTY LOCATED: York
STREAM: Cabin Creek
DATE OF INSPECTION: October 31, 1978

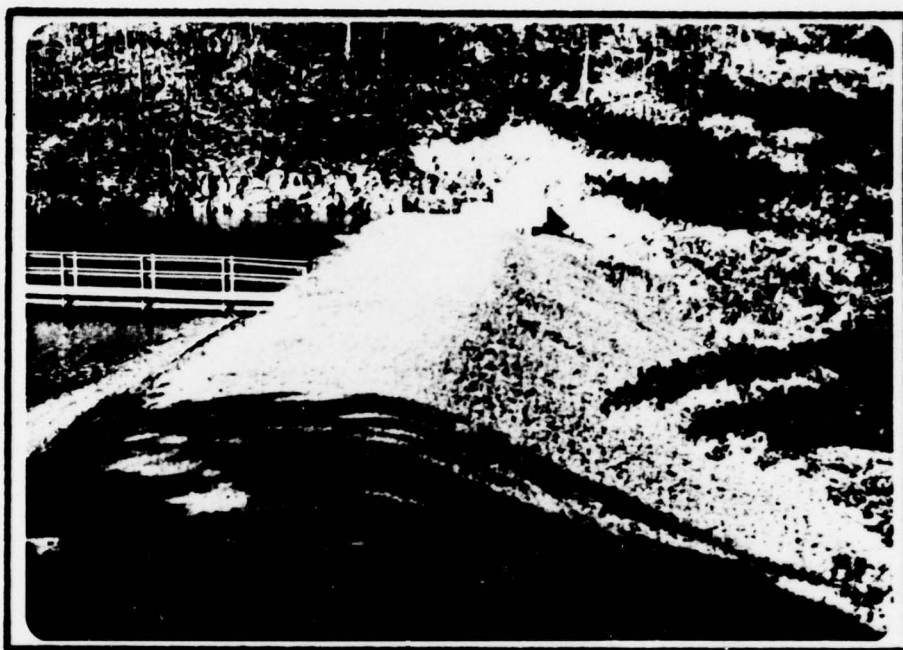
Overview of crest from right abutment.

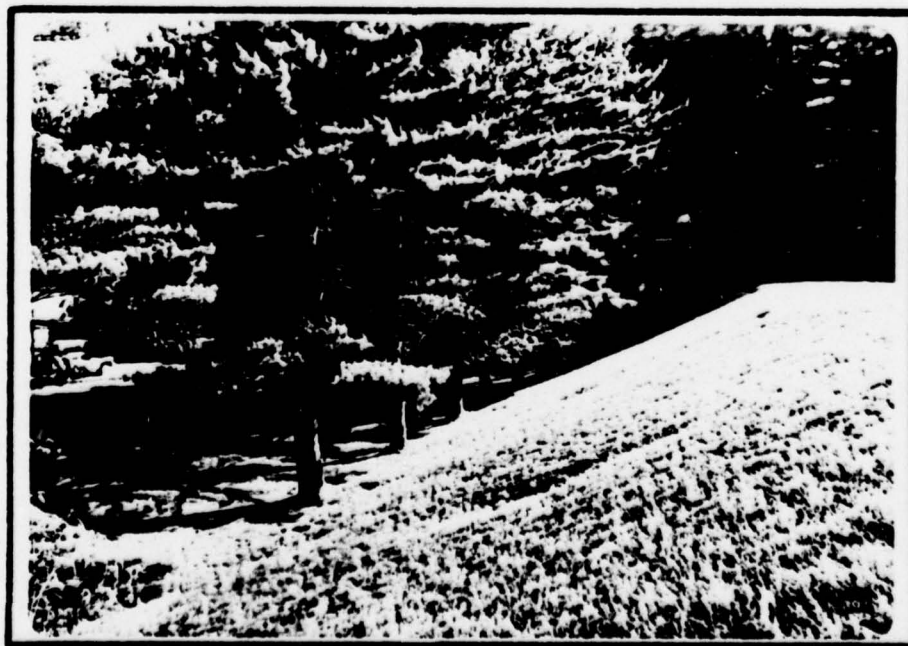
Downstream slope from left abutment.

3.2 Evaluation. Visual inspection did not reveal any serious signs of instability. The embankment is in need of minor maintenance particularly repairing the erosion on the downstream slope. Several seeps and wet areas were noted on the downstream slope and at the toe. No evaluation has been conducted on these areas and their effect on the stability of the embankment. Since no stability analysis has been conducted to date, it is recommended that it be conducted under conditions observed in the field.

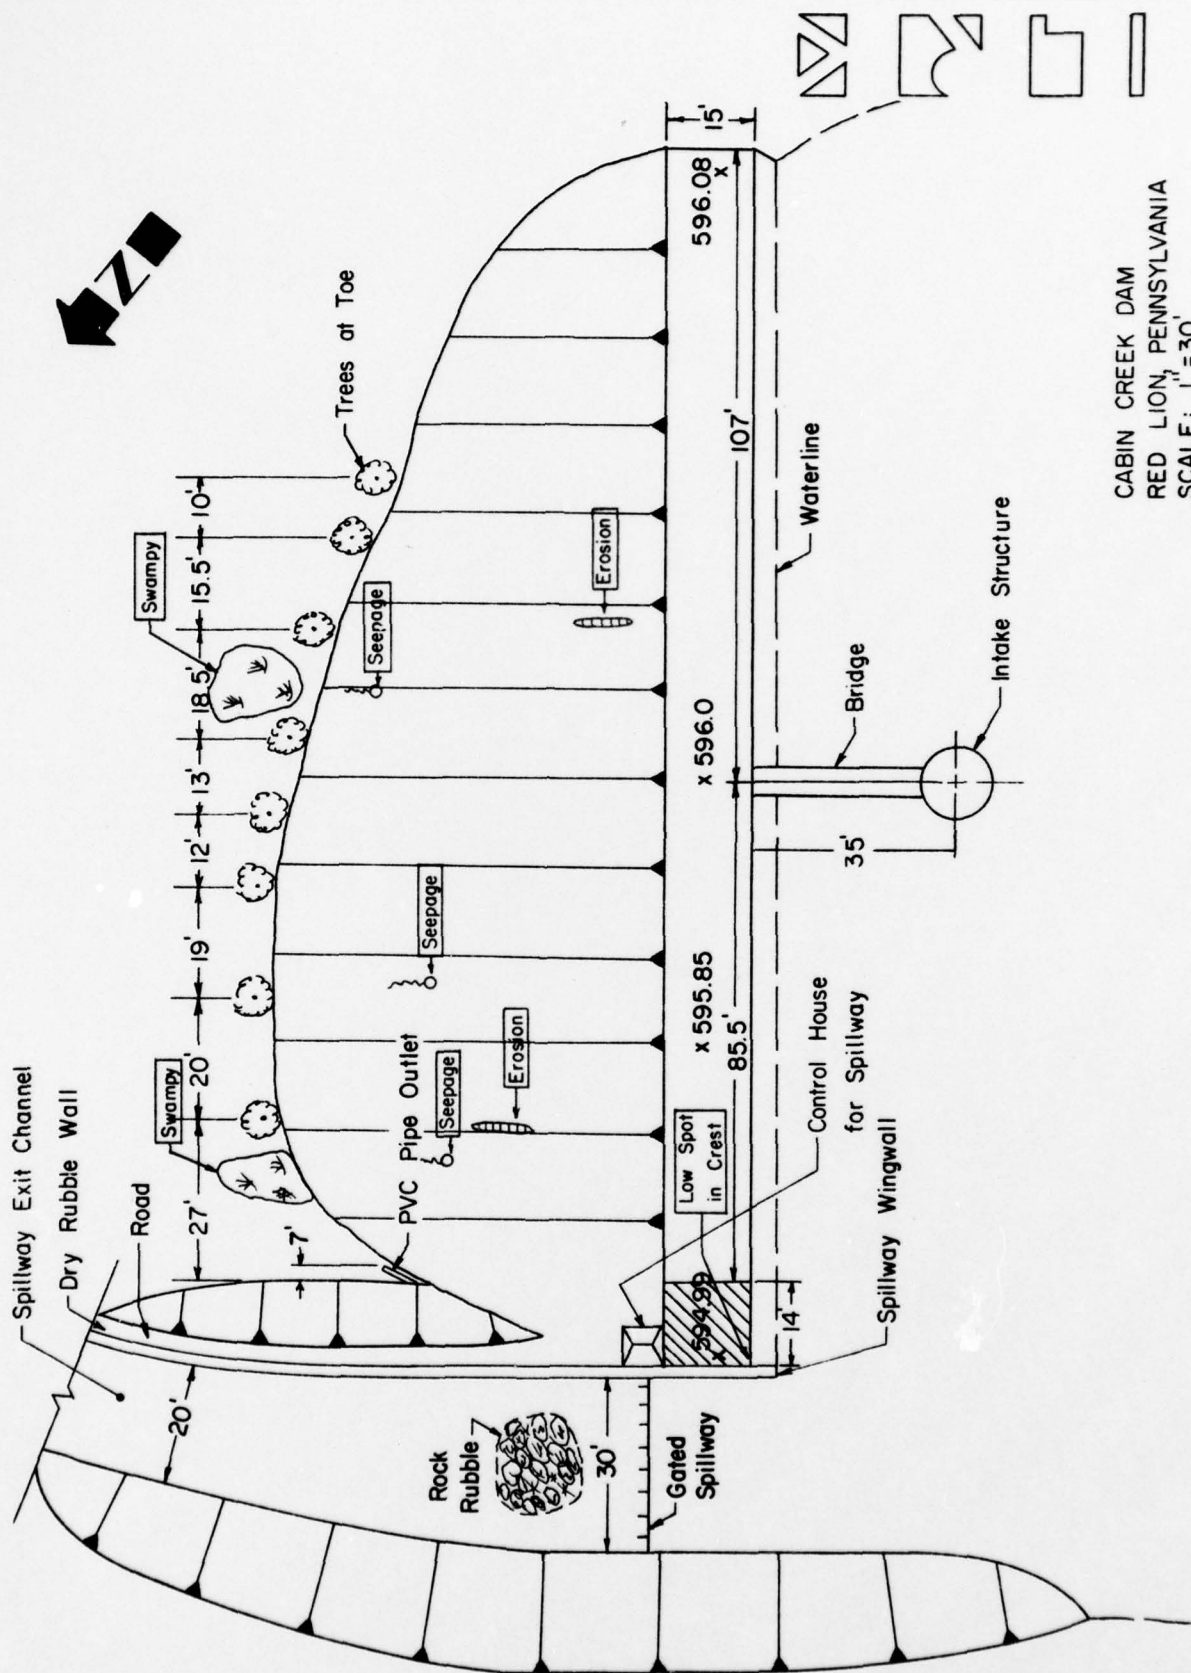
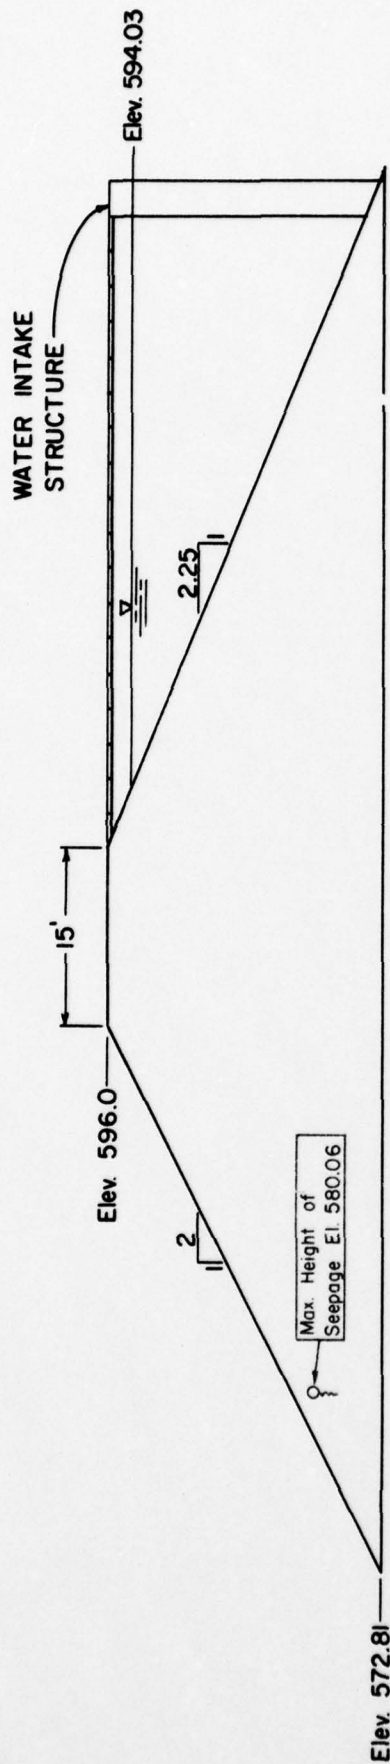
CABIN CREEK DAM
 RED LION, PENNSYLVANIA
 SCALE: 1" = 30'

b. Dam. The dam appears to conform closely to the construction drawings. From a brief survey conducted during the inspection it was determined that several low spots are present on the crest toward the left abutment. One area adjacent to the emergency spillway wingwall is approximately one (1) foot low. Several erosion gullies were noted on the downstream slope. These gullies may have resulted from the 1972 overtopping. Several seepage zones were noted on the downstream slope. The seepage zones were small (2' x 2') and minimal flow was noted. Two (2) wet areas (6' x 6') were noted at the toe of the embankment. Approximately seven (7) large trees are growing at the toe of the embankment. See drawing on pages 7 and 8 for location of seepage and wet areas.

1. The owner should monitor the wet areas and seeps and take necessary remedial measures if the seeps are found to be increasing.

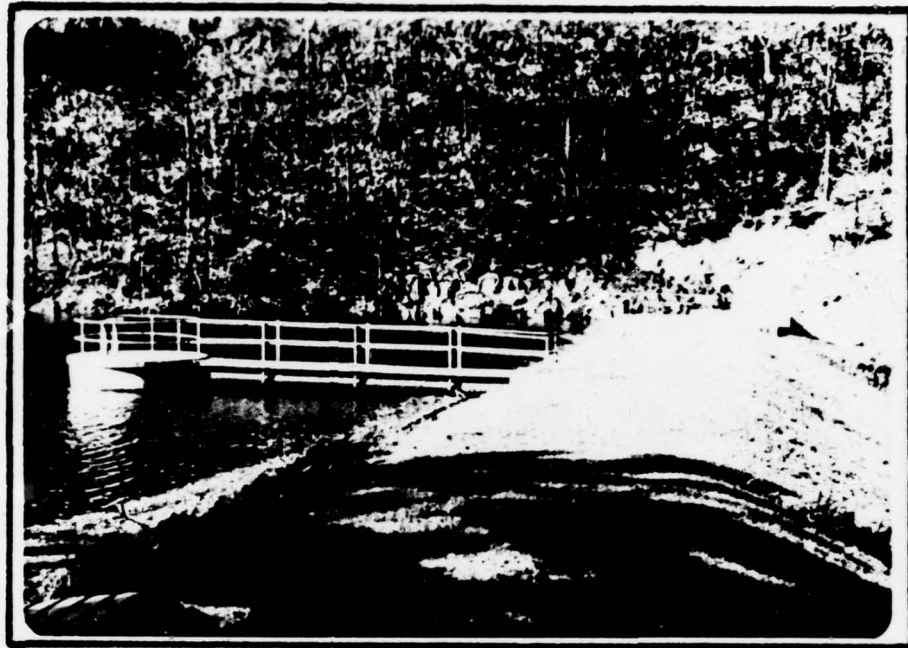
Photograph No. 1

The intake tower appeared to be in good condition. The intake gates and 12 inch cast iron supply line were not observed. The 12 inch pipe runs directly into the filtration plant. It is reported by the caretaker that the bottom intake gate is silted shut.

Intake structure and spillway gate control building.

6. Silt from the lower intake tower gate should be removed so that the intake can act as an emergency drawdown.

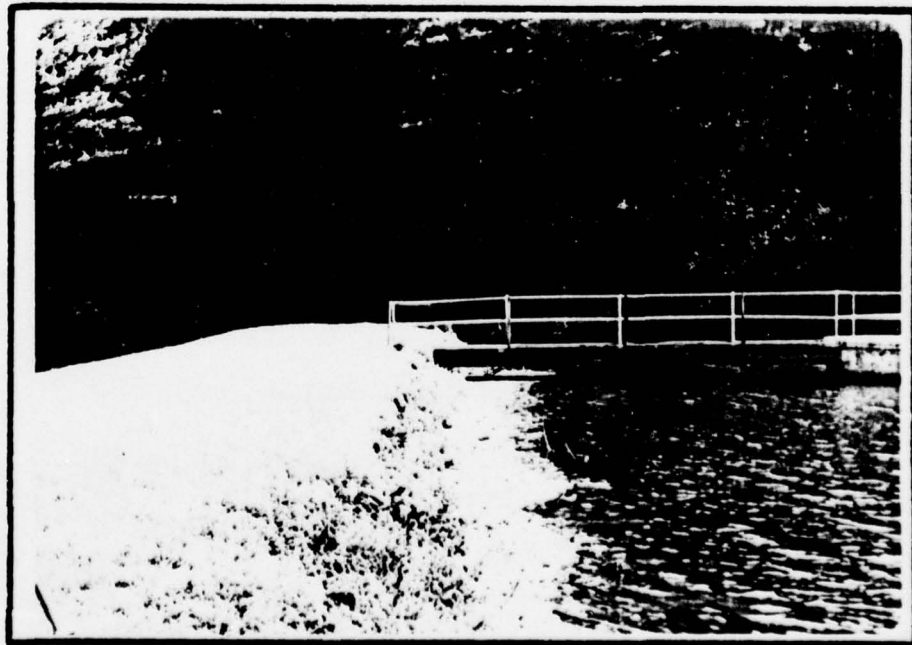
Photograph No. 2

View of upstream slope.

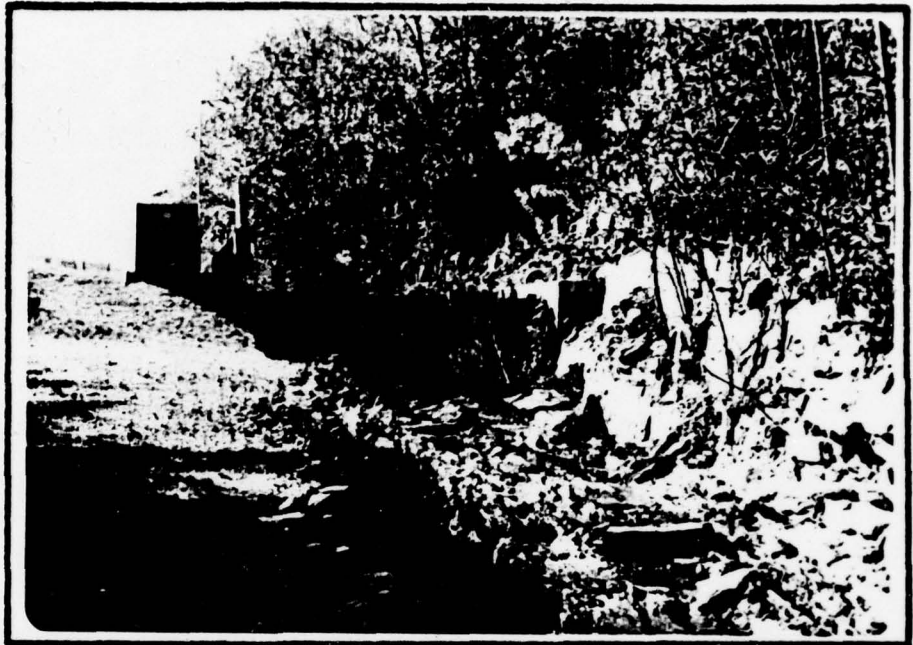
Photograph No. 3

The rock debris in the spillway exit channel has some restricting effect on the capacity of the channel. The trees growing on the exit channel highwall may cause landsliding. Visual observations indicate that the Bascule gate is in good condition. The condition of the water supply line is unknown.

Some debris was noted in the spillway exit channel. The debris was apparently from a small slide in the left slope of the channel. Maintenance should be performed on the channel slope to prevent future slides.

Spillway exit channel, debris in channel and hydraulically controlled spillway.

5. The debris in the emergency spillway exit channel should be removed. Trees on the highwall should be removed.

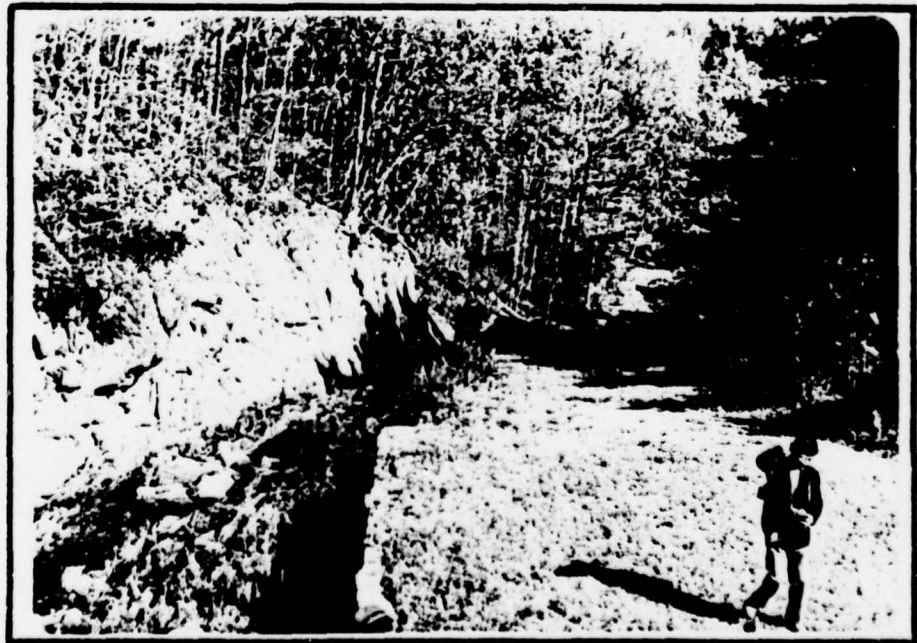
Photograph No. 4

The exit channel is cut in rock with a dry rubble rock embankment acting as a dike to confine flow to the channel. A recent rock fall has created a partial obstruction to flow. Trees are growing on the exit channel highwall.

Looking down spillway exit channel.

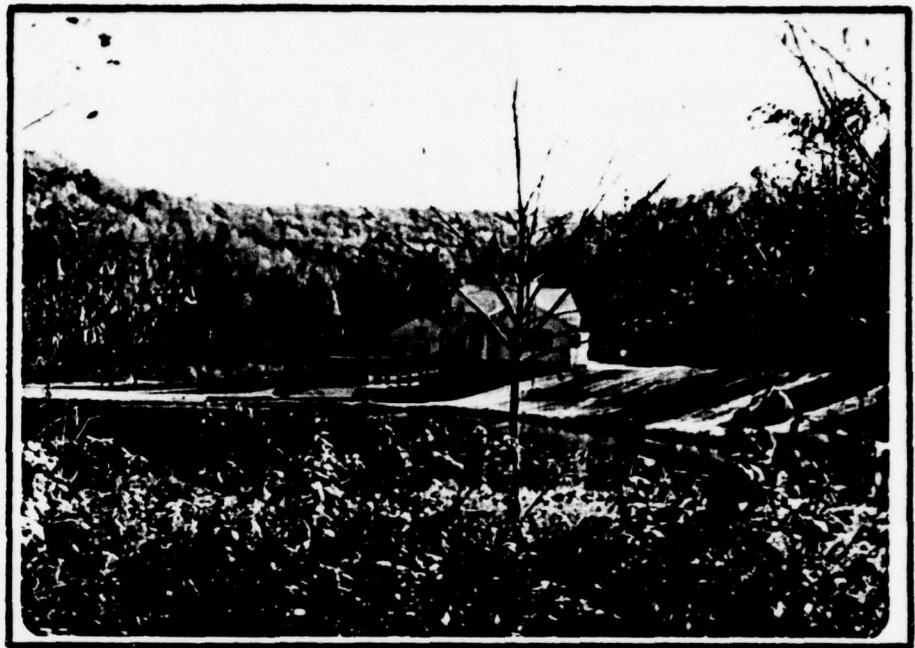
Photograph No. 5

Gun Club - First downstream building.

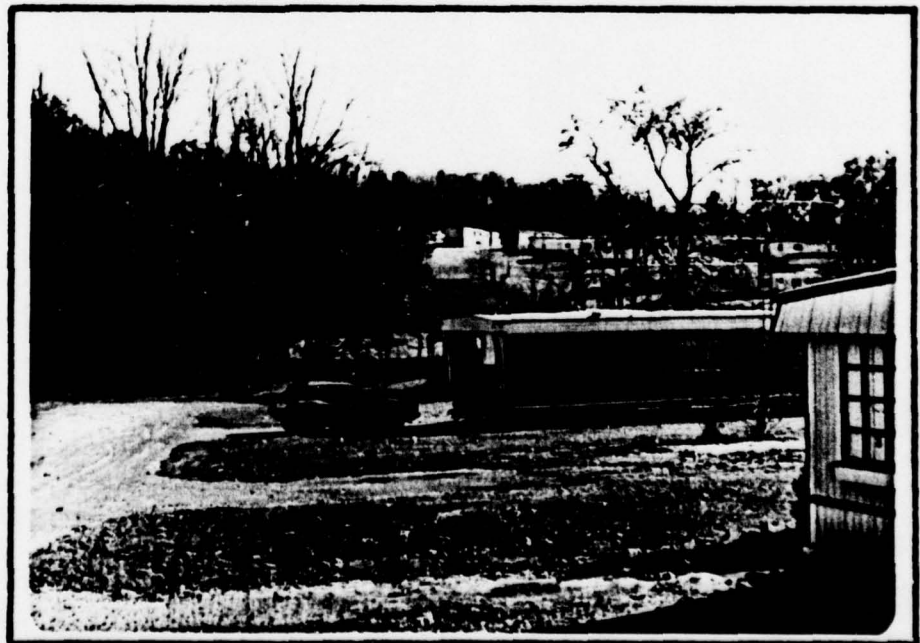
Photograph No. 6

Mobil home park at Margaretta Furnace.
